**Flood Control Project Maintenance
Levee Inspections**

Maintenance Issue Types Only, Levee Inspection Report By Mile - Fall 2014

Reclamation District No. 2095 Paradise Cut

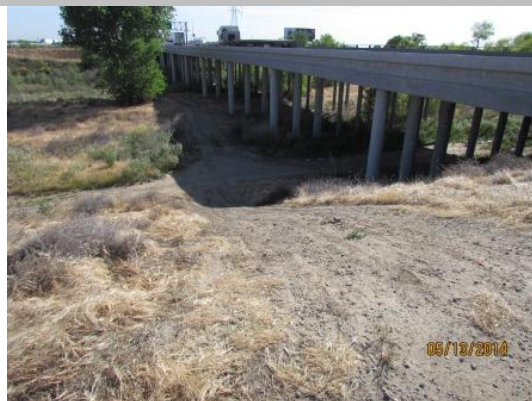
Photo 1 of 1 : FA_2014_RD2095_322_134_20141001_00012.jpg

LM Start	0.11	Rating **	A/W	Issue No.	134
LM End	0.11	Issue Type +	Ma	Location *	WS
Category	Earthen Levee			GPS Latitude/Longitude	
				Start	End
Item	Slope Stability			37.770212 °	37.770212 °
				-121.325675 °	-121.325675 °
DWR ID	DWR_RD2095_01_s_2014_134				
Action/Comments					
Repair the levee slope damaged by vehicle traffic and prevent access where possible.

View of the vehicle access on the waterside levee slope.

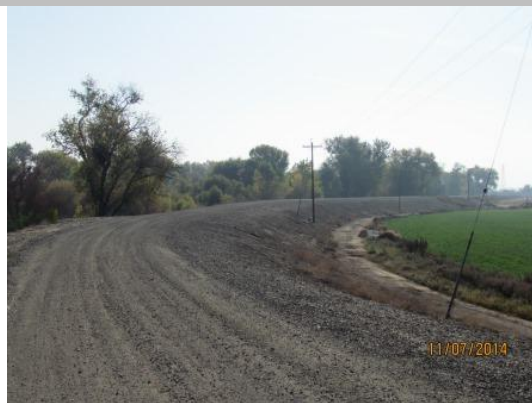
Photo 1 of 1 : FA_2014_RD2095_322_12_20141110_00017.jpg

LM Start	0.16	Rating **	A	Issue No.	12
LM End	0.16	Issue Type +	Ma	Location *	LS
Category	Earthen Levee			GPS Latitude/Longitude	
				Start	End
Item	Vegetation			37.769889 °	37.769889 °
				-121.324793 °	-121.324793 °
DWR ID	DWR_RD2095_01_f_2014_12				
Action/Comments					
Control annual grass and weeds on the levee slopes and easements.

View of acceptable vegetation maintenance.

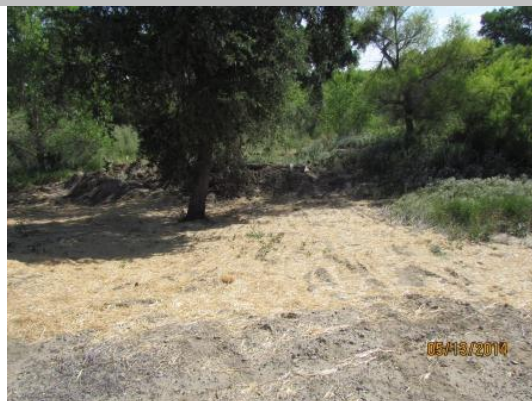
Photo 1 of 1 : FA_2014_RD2095_322_13_20141001_00009.jpg

LM Start	0.42	Rating **	A/W	Issue No.	13
LM End	0.42	Issue Type +	Ma	Location *	WS
Category	Earthen Levee			GPS Latitude/Longitude	
				Start	End
Item	Slope Stability			37.766917 °	37.766917 °
				-121.322267 °	-121.322267 °
DWR ID	DWR_RD2095_01_s_2013_13				
Action/Comments					
Repair the levee slope damaged by vehicle traffic and prevent access where possible.					
Inspector Comments: LMA is actively controlling the slope instability.

View of the repaired waterside levee slope.

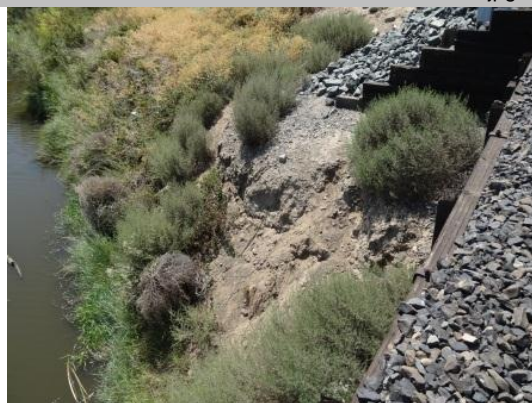
Photo 1 of 1 : SJR2014_RD2095U01RM6.74_1.jpg

LM Start	0.73	Rating **	M	Issue No.	1
LM End	0.74	Issue Type +	Ma	Location *	WS
Category	Supplemental			GPS Latitude/Longitude	
				Start	End
Item	DWR Erosion Survey			37.763630 °	37.763630 °
				-121.319000 °	-121.319000 °
DWR ID					
Action/Comments					
Inspector Comments: 08/26/2014: No significant change observed. 08/28/2013: No significant change observed. 07/18/2012: No significant change observed. 09/02/2011: No significant change observed. 09/22/2010: No significant change observed. There is now considerable vegetation at the water line and along the lower berm slope. However, the erosion on the lower berm slope is still present and has not been corrected. 08/06/2010: Recommended for local maintenance issue, per CLRO. 07/29/2009: No major change since last visit; noticeable vegetation growth; erosion is on berm, but if left untreated, it will eventually erode into levee prism; site is recommended for annual assessment and monitoring of the site, per CLRO CES 2008 Report; Site # is the same as RM6.80,LM0.73; previously rated "U". 07/22/2008: Downstream of WPRR near siphon pipe & pump; sandy levee; visited by Jeff Van Gilder and LRO in 2008 for repair assessment; scouring downstream of RR crossing, possibly caused by eddy effects. 03/13/2007: Site visited on 03/13/2007. [2014 Site ID:RD2095U01RM6.74]

Direct view of the erosion upstream of Railroad bridge.

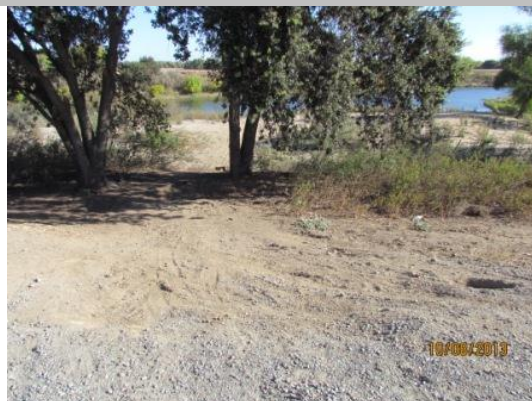
Photo 1 of 1 : FA_2014_RD2095_323_9_20141001_00005.jpg

LM Start	0.03	Rating **	A/W	Issue No.	9
LM End	0.03	Issue Type +	Ma	Location *	WS
Category	Earthen Levee			GPS Latitude/Longitude	
				Start	End
Item	Slope Stability			37.758986 °	37.758986 °
				-121.307854 °	-121.307854 °
DWR ID	DWR_RD2095_02_s_2013_9				
Action/Comments					
Repair the levee slope damaged by vehicle traffic and prevent access where possible.

View of the vehicle tire ruts on waterside levee slope.

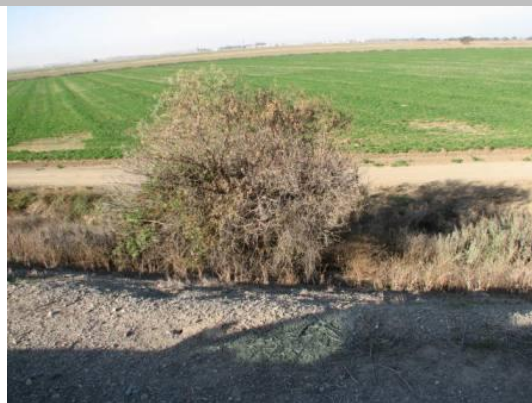
Photo 1 of 1 : FA_2014_RD2095_323_6_20141001_00004.jpg

LM Start	0.62	Rating **	A/W	Issue No.	6
LM End	0.62	Issue Type +	Ma	Location *	LS
Category	Earthen Levee			GPS Latitude/Longitude	
				Start	End
Item	Vegetation			37.751668 °	37.751668 °
				-121.304302 °	-121.304302 °
DWR ID	DWR_RD2095_02_s_2012_6				
Action/Comments					
Elderberries are blocking visibility and flood fight capability.

11/01/2011 Elderberry bush at landside toe.

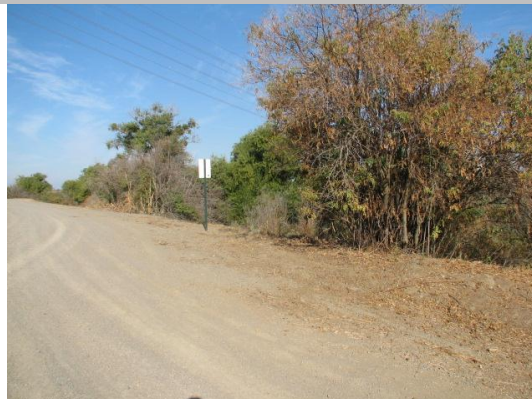
Photo 1 of 1 : FA_2014_RD2095_323_941_20141001_00013.jpg

LM Start	0.98	Rating **	U	Issue No.	941
LM End	0.98	Issue Type +	Ma	Location *	WS
Category	Earthen Levee			GPS Latitude/Longitude	
				Start	End
Item	Vegetation			37.749706 °	37.749706 °
				-121.299237 °	-121.299237 °
DWR ID	DWR_RD2095_02_s _ 2012_941				
Action/Comments					
Elderberries are blocking visibility and flood fight capability. Inspector Comments: Dense bush within 20' of crown on waterside slope.

Elderberry blocks visibility of levee slope.

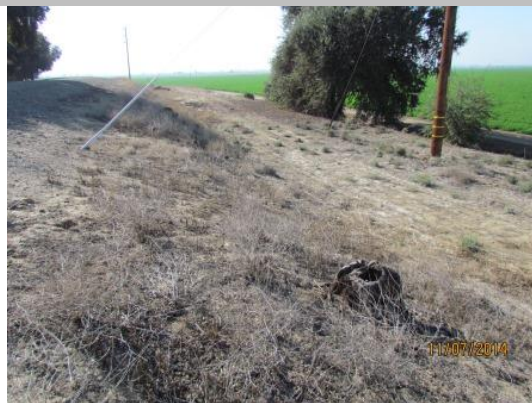
Photo 1 of 1 : FA_2014_RD2095_323_3_20141110_00016.jpg

LM Start	1.10	Rating **	N	Issue No.	3
LM End	1.10	Issue Type +	Ma	Location *	LS
Category	Earthen Levee			GPS Latitude/Longitude	
				Start	End
Item	Trim / Thin Trees			37.748184 °	37.748184 °
				-121.298995 °	-121.298995 °
DWR ID	DWR_RD2095_02_s _ 2012_3				
Action/Comments					
Tree stumps.					
Inspector Comments: 4 stumps

View of the tree stumps on the landside levee slope..

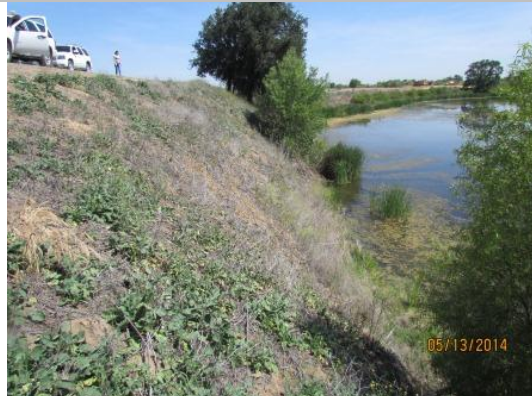
Photo 1 of 1 : FA_2014_RD2095_323_195_20141001_00011.jpg

LM Start	1.35	Rating **	A/W	Issue No.	195
LM End	1.35	Issue Type +	Ma	Location *	WS
Category	Earthen Levee			GPS Latitude/Longitude	
				Start	End
Item	Erosion / Bank Caving			37.744746 °	37.744746 °
				-121.297695 °	-121.297695 °
DWR ID	DWR_RD2095_02_s_2014_195				
Action/Comments					
Note and monitor erosion site.

View of the erosion on the waterside levee slope possibly eroding into the levee prism.

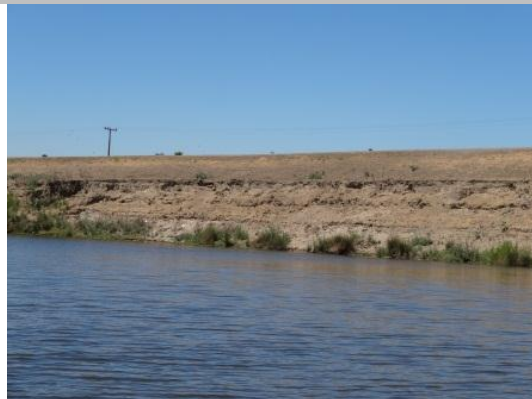
Photo 1 of 1 : SJR2014_RD2095U02RM60.62_1.jpg

LM Start	1.77	Rating **	M	Issue No.	1
LM End	1.80	Issue Type +	Ma	Location *	WS
Category	Supplemental			GPS Latitude/Longitude	
				Start	End
Item	DWR Erosion Survey			37.740196 °	37.740196 °
				-121.297662 °	-121.297662 °
DWR ID

Inspector Comments: 7/02/2014: No significant change observed.
 08/28/2013: No significant change observed.
 09/13/2012: The site has been visited by land survey. The vegetation on the site shows the erosion has not developed significantly from the last survey.
 The site was not visited by boat survey due to the limitation of navigable waterway.
 08/23/2011: No significant change observed.
 9/22/2010: No significant change observed. There is moderate vegetation growth on the berm. Despite the erosion occurring on the berm, corrective action should be taken before the issue becomes severe.
 9/29/2009: Site is immediately downstream of a section of existing rip rap; there is a 20-foot berm remaining; berm will continue to erode unless erosion is mitigated; Site# is the same as RM62.6, LM1.87; recommended for annual assessment, per CES Evaluation 2008 Report 2006: Visited 10/20/06 [2014 Site ID:RD2095U02RM60.62]

View of the erosion.
